Jackson Street Sewer Detailed Investigation Timeline Description

Jackson Street Sewer Figures

North Yard – Bulkhead Area Figures

North Yard Figures

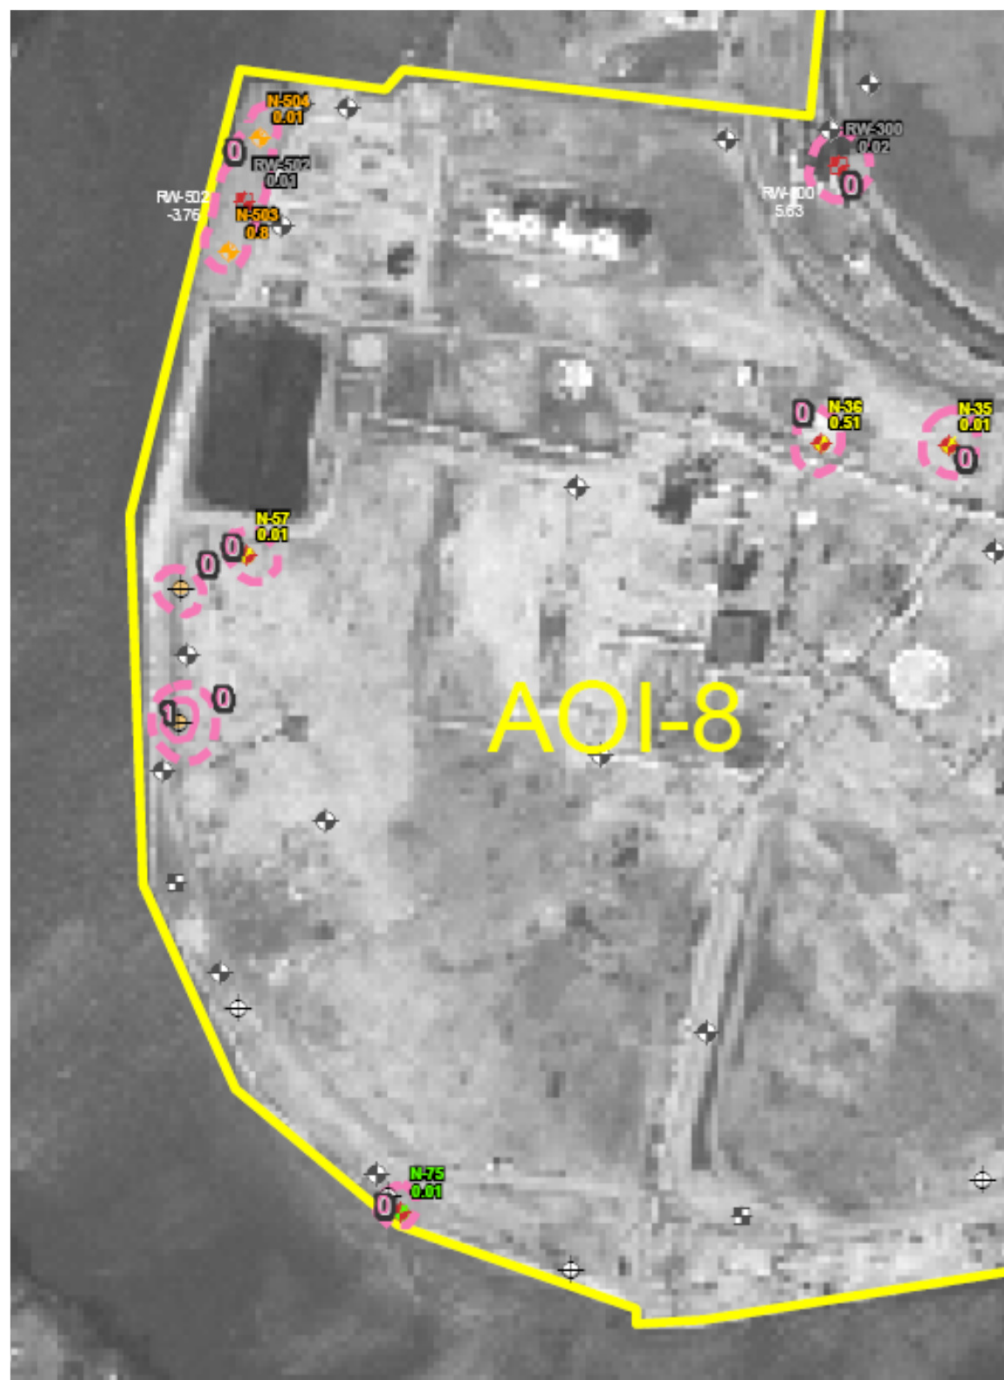
Point Breeze 4th
Quarter 2005
Report (pg. 50)

OBSERVATIONS

Plume RW-502, N-503 and N-504 –
thickness decreased slightly

Plume PZ-501 – no change

New Plume N-57

Plume PZ-502 – thickness decreased to
more than 1 ft thick

Plume PZ-500 – no longer present

Plume N-75, N-74 – decreased to only N-
75

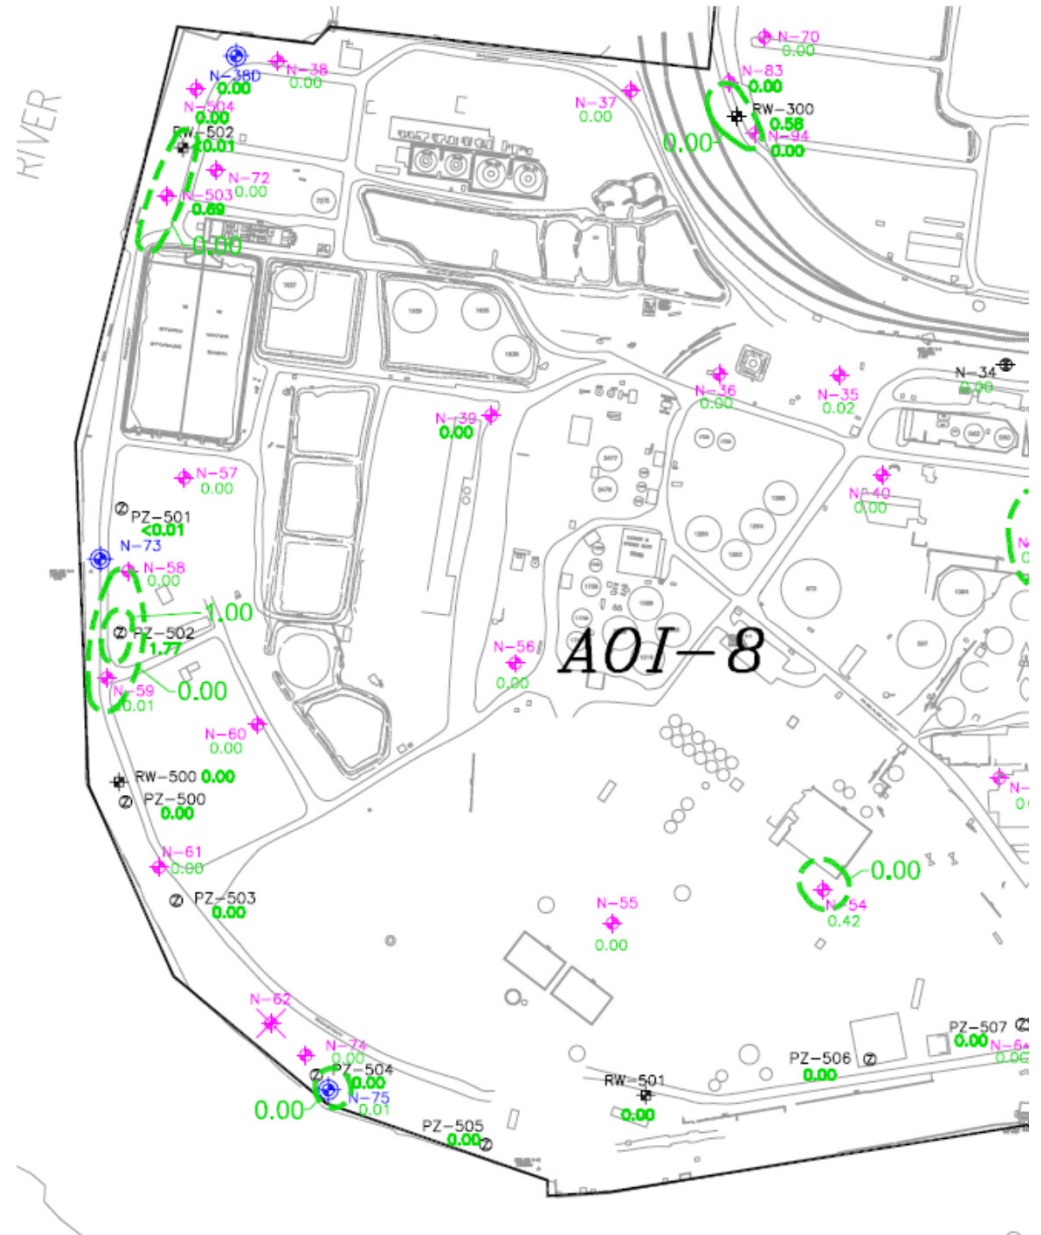
Point Breeze 2nd
Quarter 2006
Report (pg. 97)

OBSERVATIONS

Plume RW-502, N-503 and N-504 – no longer includes N-504

Plume PZ-501 – no longer present

Plume N-57 – no longer present

Plume PZ-502 – now includes N-58 and N-59

Plume PZ-500 – no longer present

Plume N-75 – no change

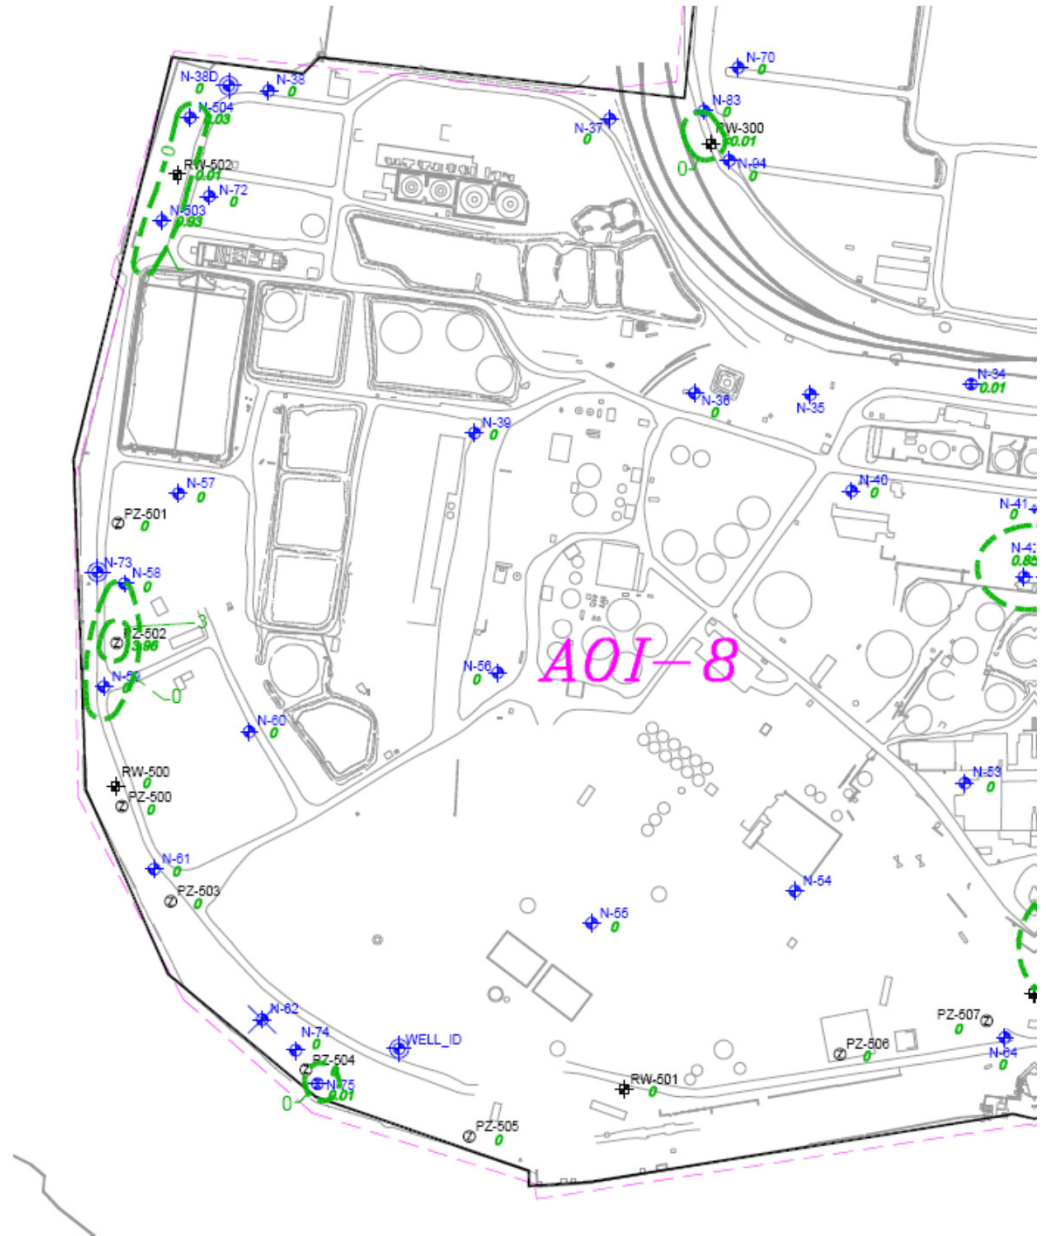
Point Breeze 4th
Quarter 2006
Report (pg. 28)

OBSERVATIONS

Plume RW-502, N-503 - now includes N-504

Plume PZ-501 – no longer present

Plume N-57 – no longer present

Plume PZ-502, N-58 and N-59- thickness increased to more than 3 ft

Plume PZ-500 – no longer present

Plume N-75 – no change

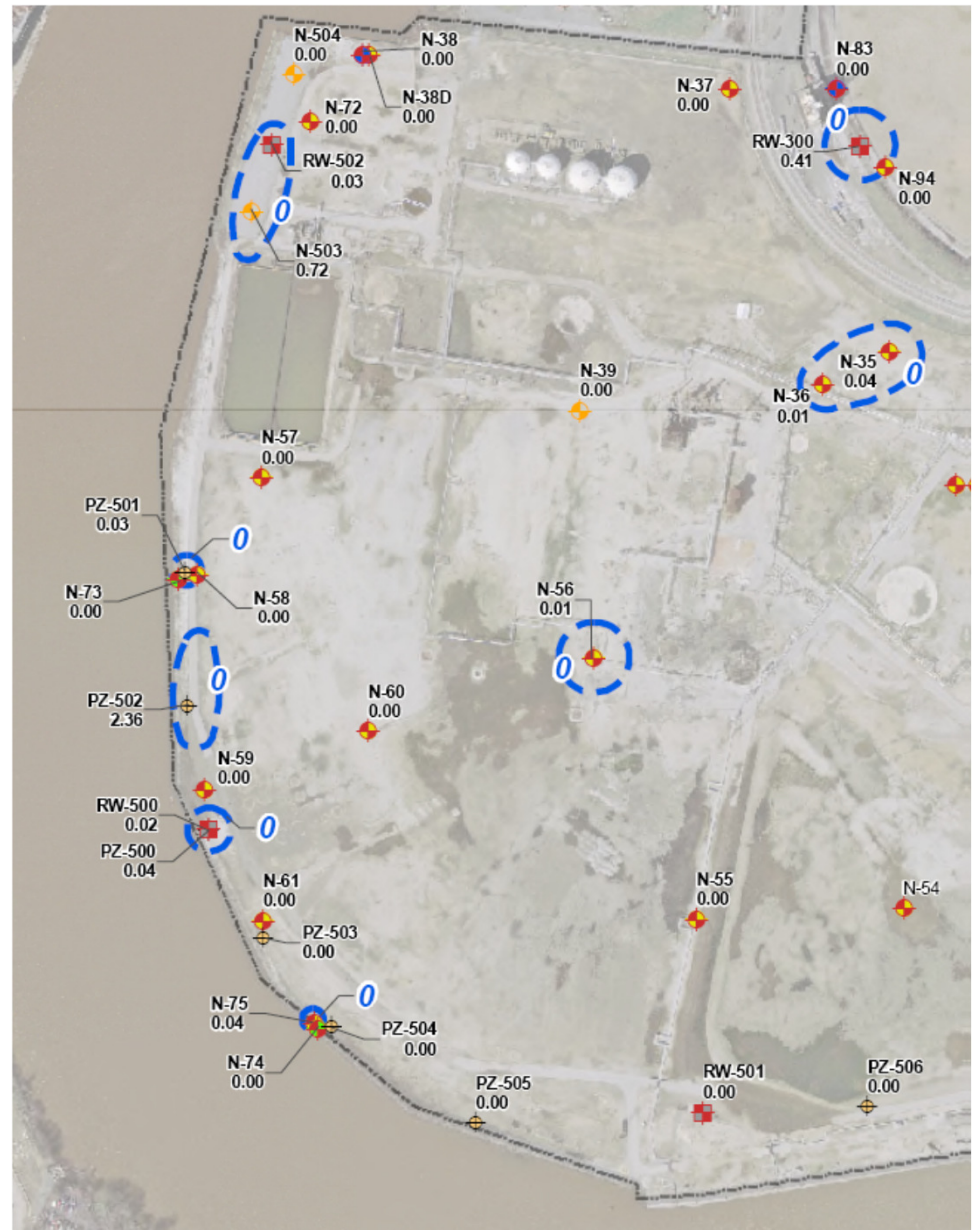
Point Breeze 4th
Quarter 2007
Report (pg. 35)

OBSERVATIONS

Plume RW-502, N-503 and N-504 – no longer includes N-504

Plume PZ-501 – returned

Plume N-57 – no longer present

Plume PZ-502, N-58 and N-59- no longer includes N-58 and N-59

Plume PZ-500 – returned and includes RW-500

Plume N-75 – thickness increased slightly

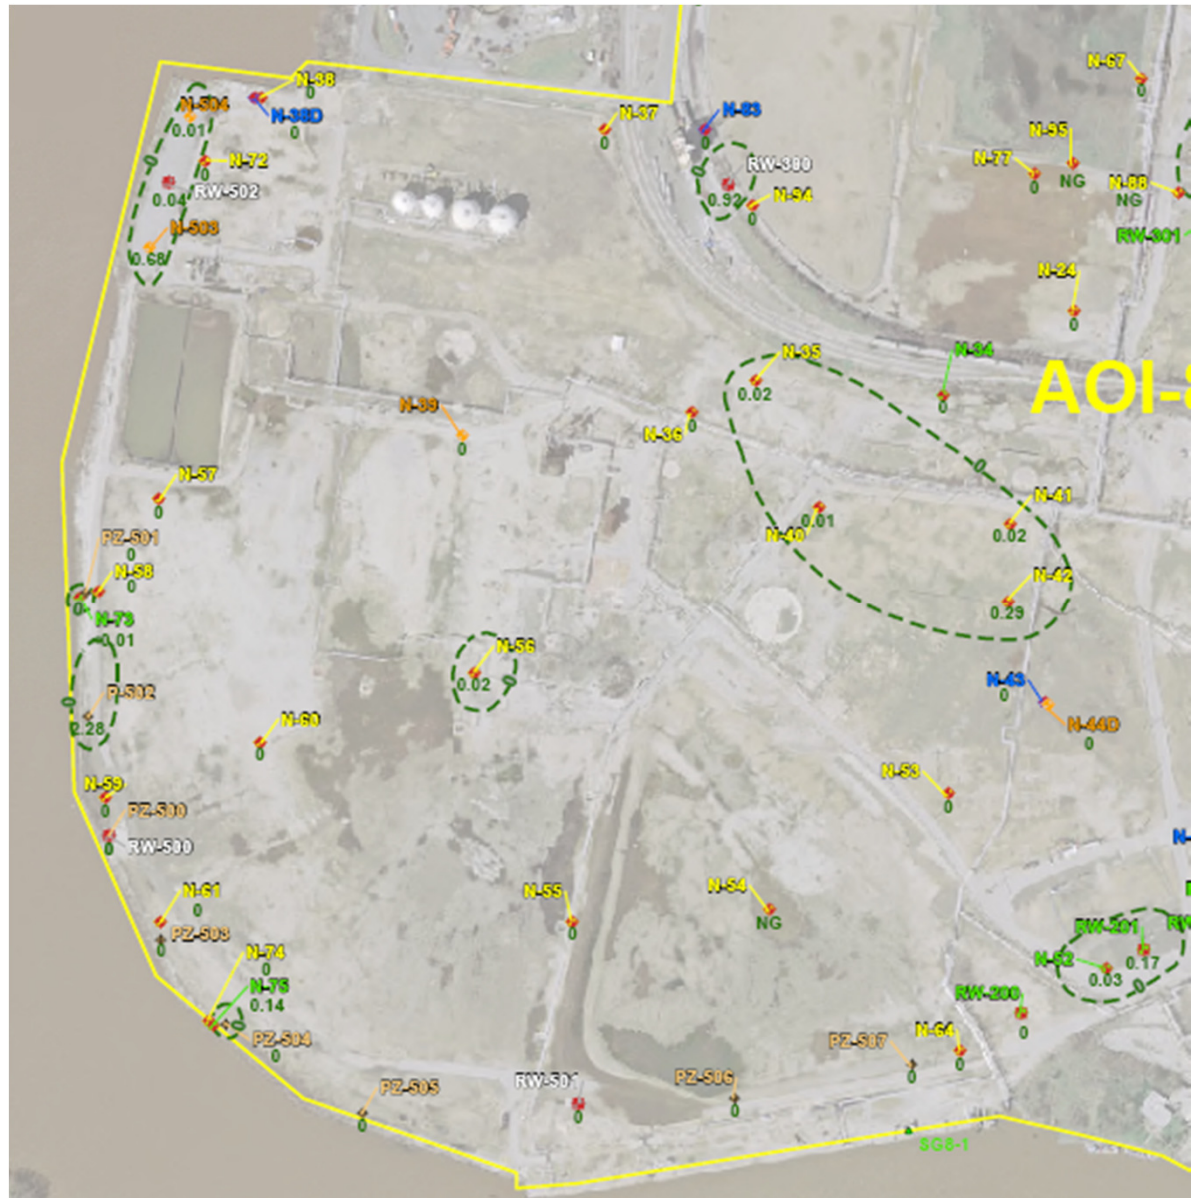
Point Breeze 2nd
Quarter 2008
Report (pg. 32)

OBSERVATIONS

Plume RW-502, N-503 and N-504 – no
change

Plume PZ-501 – returned and now
includes N-73

Plume N-57 – no longer present

Plume PZ-502, N-58 and N-59 – no longer
includes N-58 or N-59

Plume PZ-500 – no longer present

Plume N-75 – slight increase in thickness

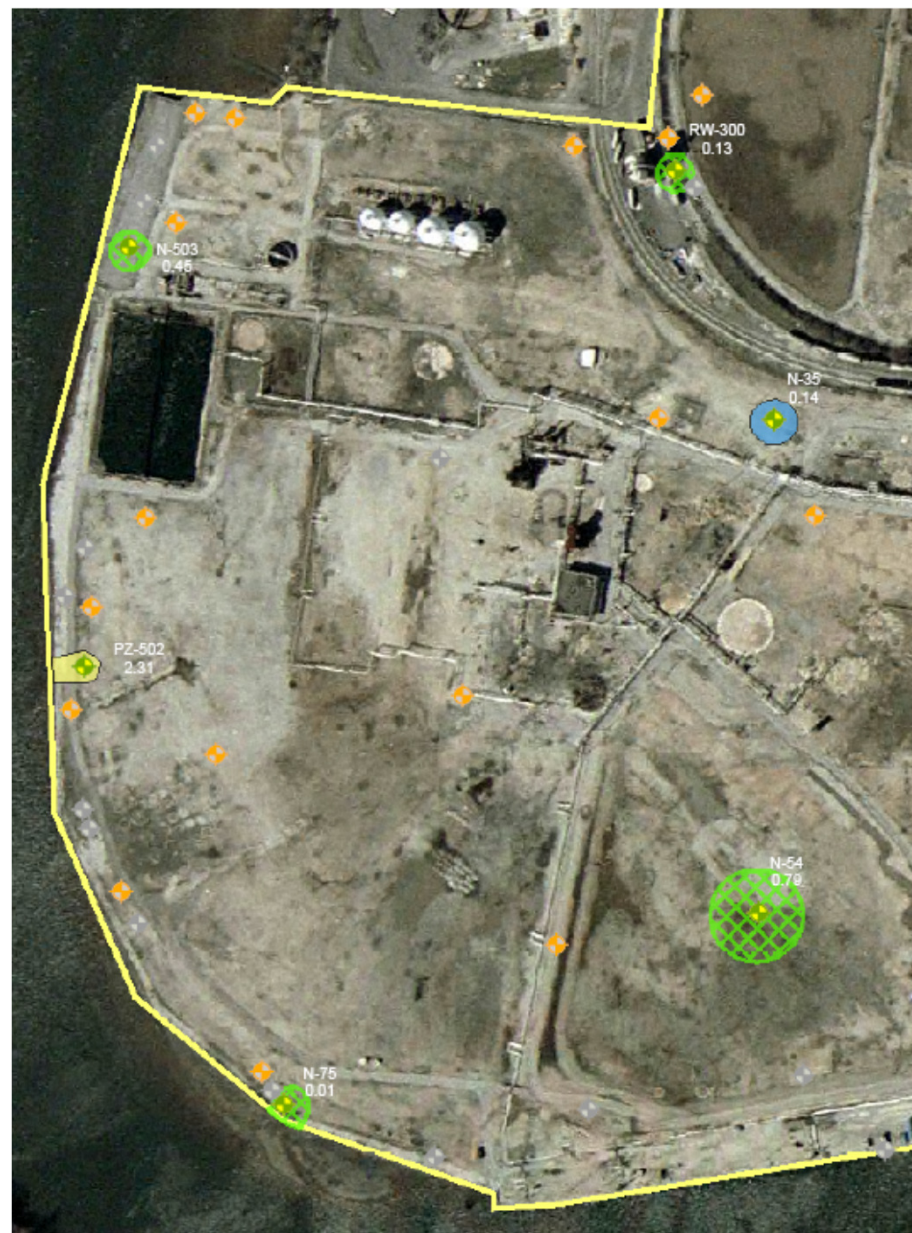
CCR - Figure 5
data collected
11/2003

OBSERVATIONS

Plume RW-502, N-503 and N-504 – no longer include RW-502 or N-504

Plume PZ-501 – no longer present

Plume N-57 – no longer present

Plume PZ-502 – increased in thickness slightly

Plume PZ-500 – no longer present

Plume N-75 – slight decrease in thickness

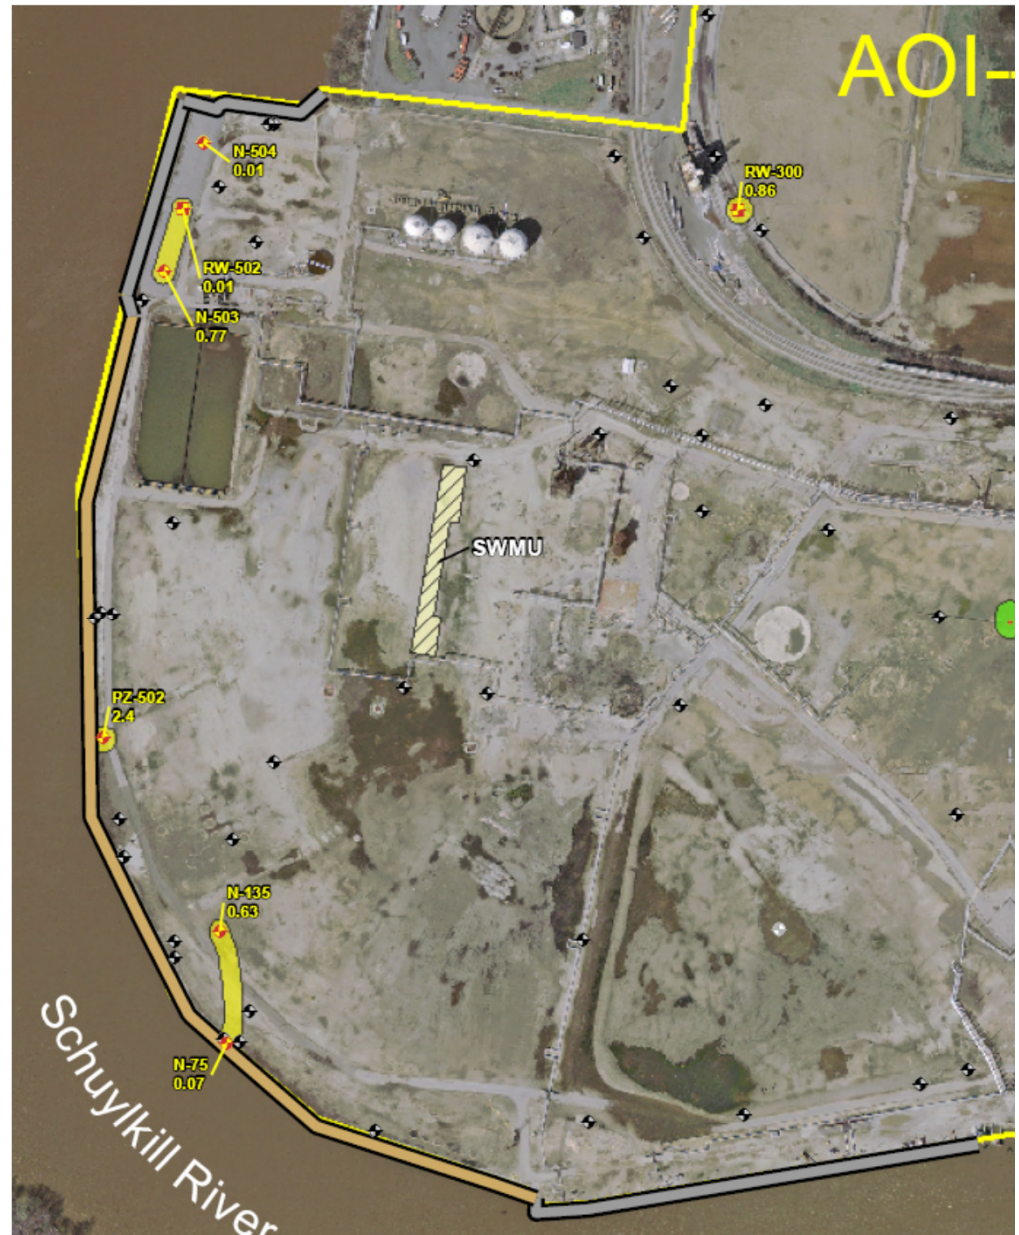
AOI 8
SCR -
Figure 11
10/2003

OBSERVATIONS

Plume N-503— now includes RW-502

Plume PZ-501 – no longer present

Plume N-57 – no longer present

Plume PZ-502 – increased in thickness slightly

Plume PZ-500 – no longer present

Plume N-75 – increase in thickness and now includes N-135

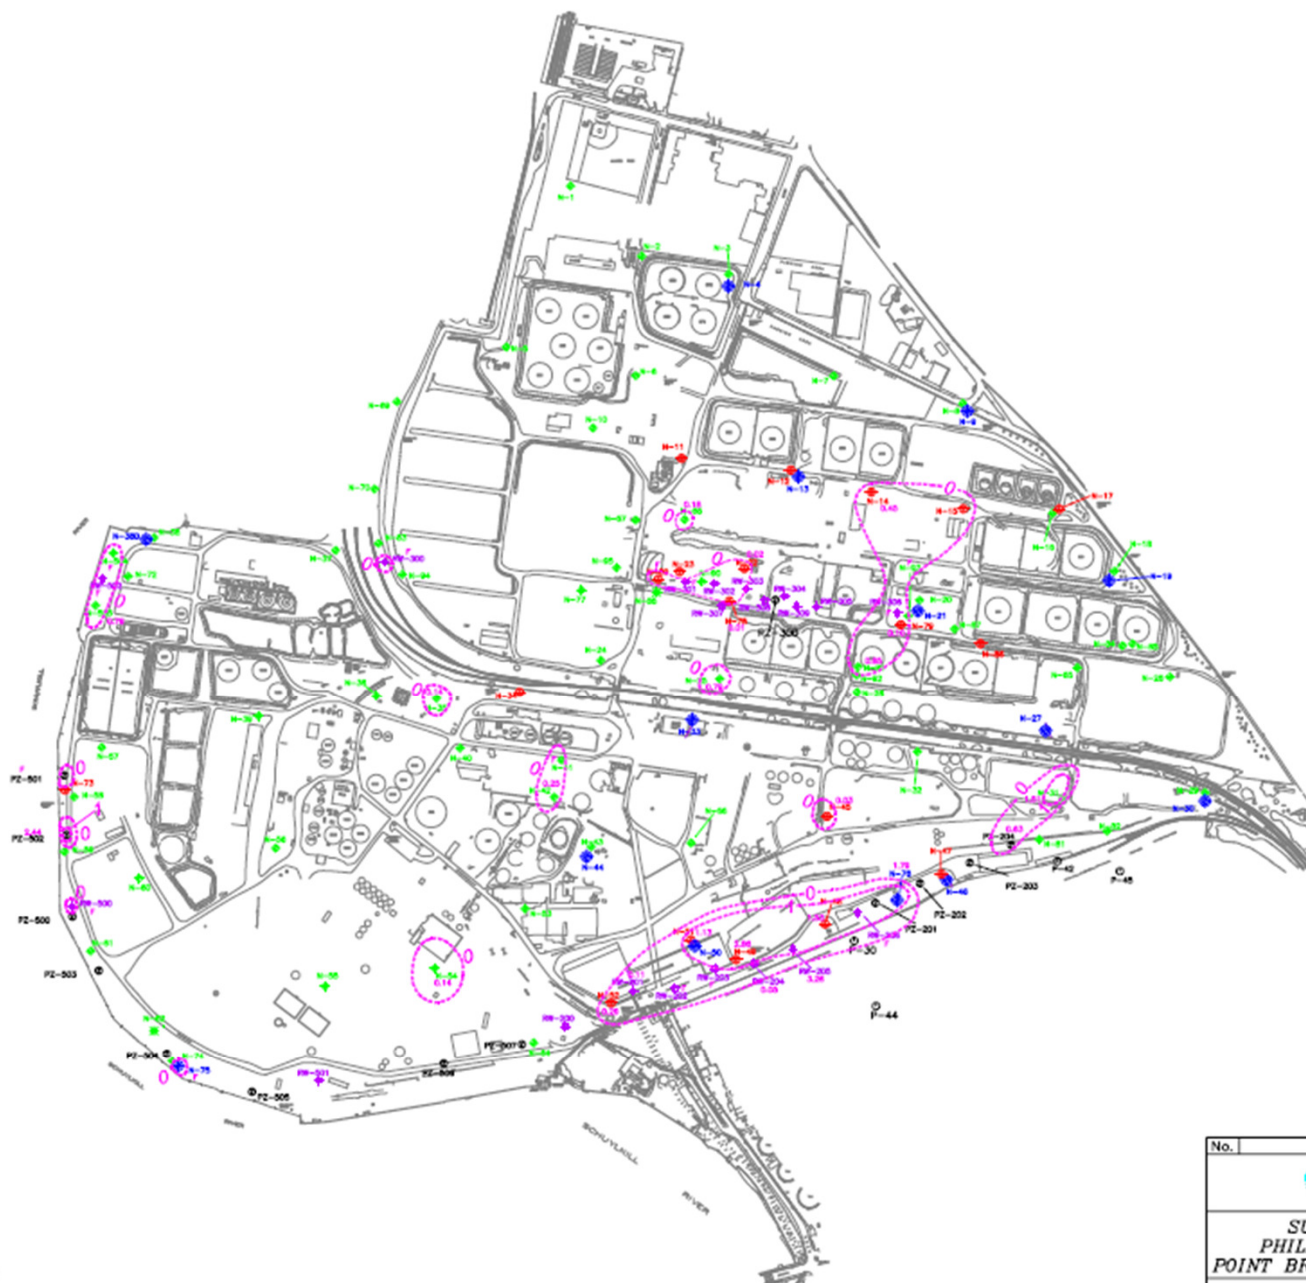
- SHALLOW MONITORING WELL
- INTERMEDIATE MONITORING WELL
- DEEP MONITORING WELL
- RECOVERY WELL
- PIEZOMETER
- POW MONITORING WELL
- DESTROYED OR ABANDONED MONITORING WELL
- 0.75 APPARENT LNAPL THICKNESS (ft)
- APPARENT LNAPL THICKNESS CONTOUR (DASHED WHERE INTERPOLATED)
- FLUX (GAL/D) (ft)
- CONTOUR INTERVAL = 1.0 ft

NOTE: CONTOURS GREATER THAN ONE (1) FOOT ARE NOT SHOWN.

THIS DRAWING IS BASED ON DRAWING 9-0-0 BY SUN COMPANY, INC.
25031
